Role of building codes and construction standards in windstorm disaster mitigation

David Henderson and John Ginger from James Cook University, examine the role of Australia's building code and construction standards in a number of windstorm disaster mitigation situations.

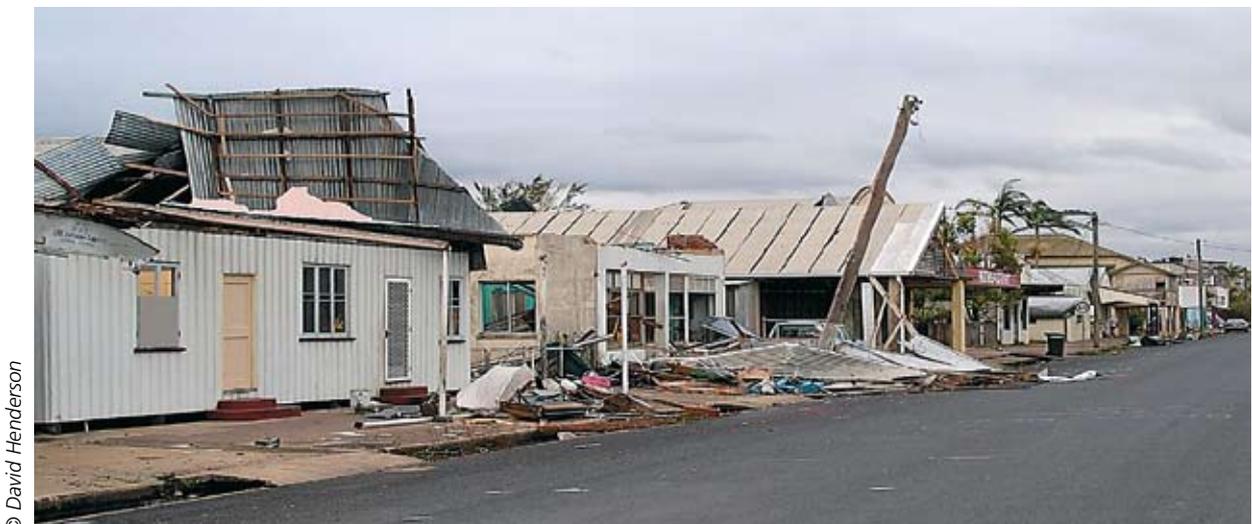
Tropical Cyclone Larry crossed the North Queensland coast in the early morning of Monday 20th March 2006, causing severe damage to buildings, agriculture, and infrastructure for power, communications and services in the Innisfail region (Figure 1). Wind damage extended well into the Atherton Tablelands and flooding was reported in the Innisfail area, the Tablelands and into the Gulf country.

Figure 1: Damage in Mourilyan from TC Larry.

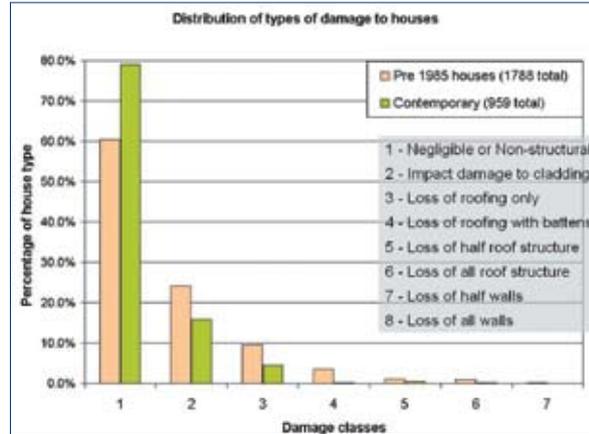
Most of the contemporary houses (post 85) were slab-on-ground houses, with reinforced masonry walls. Figure 5 shows contemporary housing suffered less structural damage than pre-1985 housing as a result of the improvements specified in the revised standards.

Figure 5 shows about 5% of post-85 houses suffered failures from wind loading (Damage Class 3-7). These failures were generally caused by under strength connections details resulting from incorrect AS4055 site classification (e.g. building a C1 house on a C3 site), the use of inappropriate building materials, errors in

Figure 5: Damage to houses following Cyclone Larry (Henderson et al., 2006)

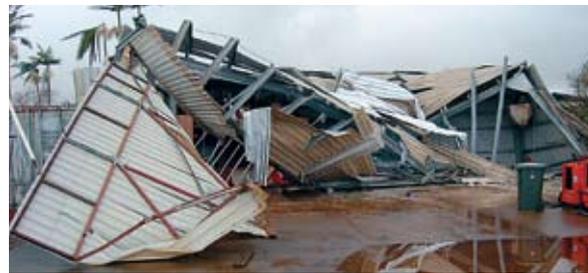
An external damage survey of commercial and industrial sheds showed that approximately 30% of these “engineered” buildings suffered damage ranging from loss of cladding through to complete collapse. This amount of damage is concerning, especially as these failures took

place at wind speeds significantly lower than the design value, exceeding the level of failures acceptable according to the BCA and relevant Standards. Of the buildings that had roller doors, 60% had failed doors, often causing additional internal damage and in some cases leading to structural failures. The major structural failures were mainly in the thin cold formed steel frame sheds (Figure 7). The heavier hot-rolled steel framed sheds performed better, notwithstanding the failure of the roller doors, or failures due to corrosion of elements.

Figure 7: Failure of cold formed steel frame shed

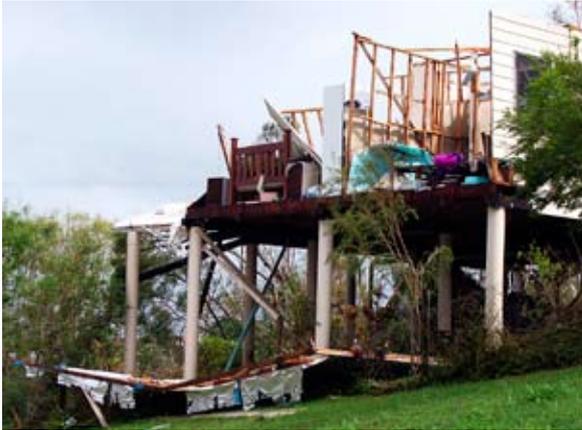
construction or poor maintenance. There were examples of structural damage to contemporary elevated houses shown in Figure 6 which is attributed to their hill-top locations which experience higher wind loads than the structural detailing catered for. Many adequately designed contemporary houses which were subjected to higher wind speeds due to topography had minimal damage.

Figure 6: Elevated house on side of hill

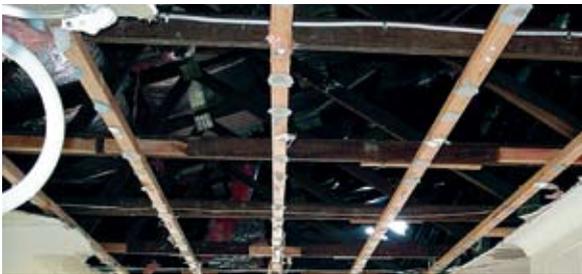
Although Figure 5 showed that about 80% of contemporary housing suffered minimal structural damage it was noted that many houses were subjected to water ingress as shown in Figure 8. A recent GA and CTS supported survey conducted by Melita (2007), details building envelope failures during TC Larry. He found that approximately 75% of post-85 houses suffered water ingress through breaches in the building envelope (broken windows, punctured cladding, failed fascia or guttering, etc) or through window “seals”, vents and under flashings. In many cases this has necessitated the refurbishment or replacement of internal linings and building contents.

Figure 8: Ceiling damaged by water ingress from debris impact to gable

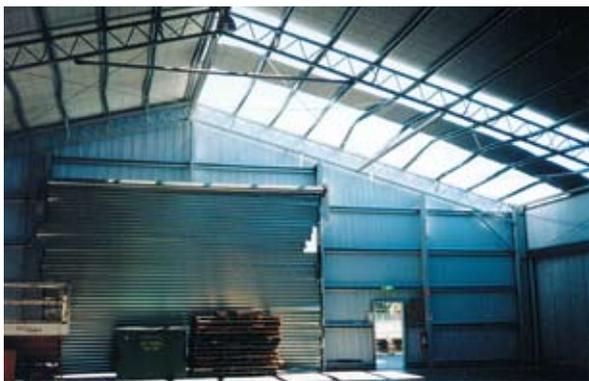
An external survey of housing, showed that approximately 5% suffered damage, mostly to tiled roofs from wind loads and debris impact (note that this excludes internal damage from water ingress, etc), in stark contrast to the more extensive damage suffered by commercial and industrial sheds. Figure 9 shows a shed with loss of cladding, buckled top hat purlins and buckled plates at the portal frame knees following the failure of the windward roller door. Note that the door has been laid back mostly in place following the event.

Approximately 50% of the sheds in the surveyed industrial area suffered some damage. The damage was mostly to roof and wall cladding and to roller-doors, with the damage levels ranging from negligible to structural collapse. There were a large number of roller door and window failures, which instigated more severe damage. It appears that the poor performance of engineered construction may be attributed to application of low internal pressure based on the assumption

that the buildings would remain nominally sealed. This assumption is invalid when considering the large percentage of roller door failures at lower than design level wind speeds..

Figure 9: Structural failure of shed from failure of roller door on windward wall

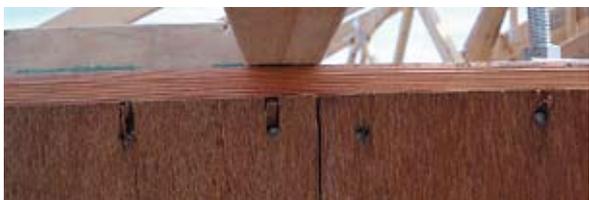
Inspections of houses under construction in both cyclonic and non-cyclonic regions have revealed common construction faults that can significantly reduce the capacity of structural elements, leading to the failure of the structure. Typical faults were missing framing anchors, misalignment of truss cleats, minimal fixings for windows and incorrect truss spacings and poor fixing installations shown in Figures 10 and 11. Design standards and manufacturers data do not account for these types of faults and poor construction practices. This is another reason why damage surveys show higher than expected failures of contemporary

Figure 10: Gun nails over driven in bracing panel.

construction. A missing or poorly installed fastener can result in the failure of a building, as adjacent fixings are overloaded and fail in a cascading effect.
