Analysis of rapid damage assessment data following severe windstorm events

Dr Daniel J. Smith^{1,4}, Dr Richard J. Krupar III^{2,4}, Dr David J. Henderson^{1,4} and Dr Matthew S. Mason^{3,4}

Case study: Brisbane hailstorm, November 2014

Case study: Tropical Cyclone Debbie, March 2017

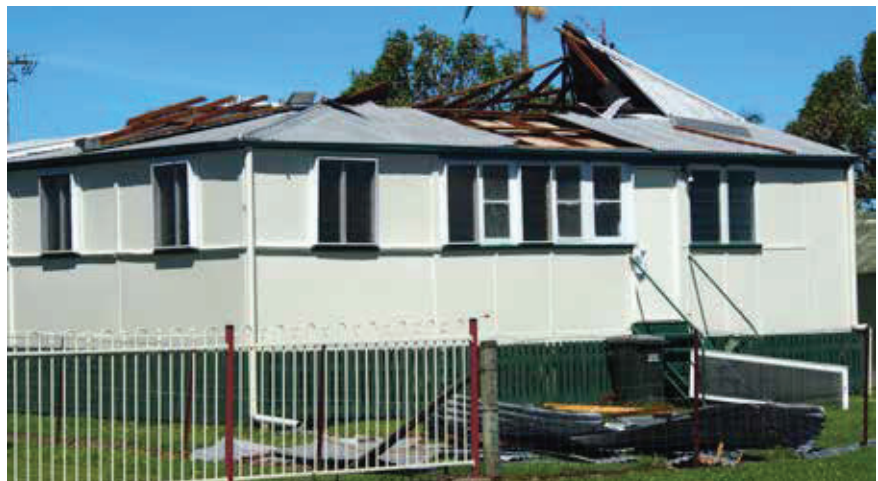
Figure 1: Severe structural roofing failure in Proserpine from Tropical Cyclone Debbie.

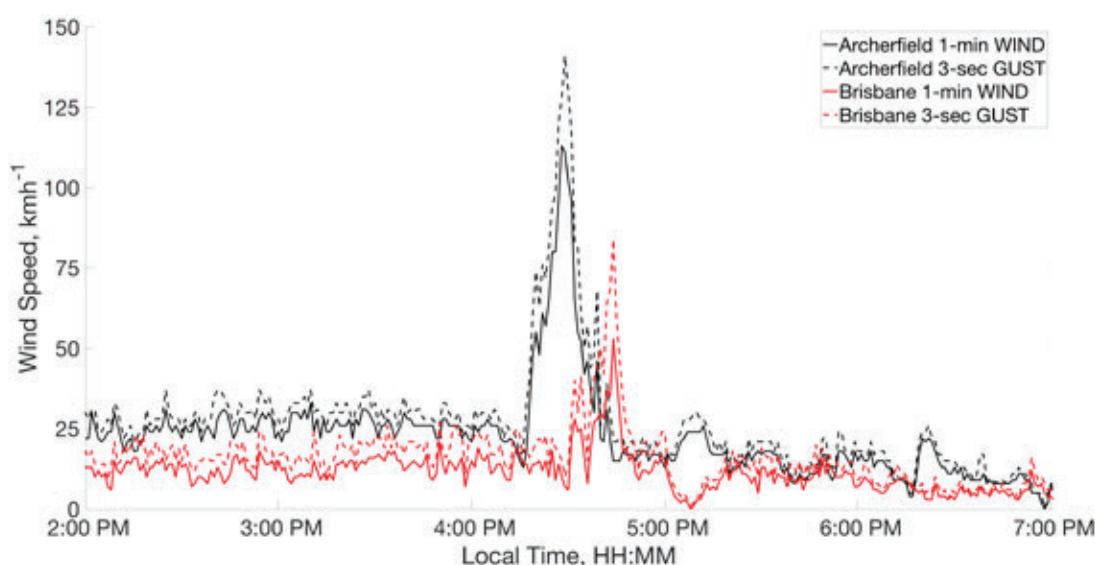
Figure 2: Archerfield and Brisbane AWS one-minute mean wind speed (WIND in km/h) and maximum three-second gust (GUST in km/h) wind histories. Measurements were collected on 27 November 2014 and time is shown in local standard time on the x-axes.

At the time of the event, a BoM S-band Doppler radar (Mt Stapylton) and dual-wavelength research Doppler radar (CP2) were simultaneously scanning the supercell. Beneath the Doppler radar sweeps, two AWSs (Archerfield Airport, Brisbane) were also recording wind data at 10-m (Figure 2). Following the event, QFES conducted RDAs throughout affected suburbs of Brisbane to gather information about the extent of damage caused by the storm. Given the unique collection of Doppler radar, AWS and ground-based RDA data during and after the storm, the damage analysis in this study aimed to compare the lowest available (i.e. 200 m) Doppler radar data with the QFES RDA observations to investigate any relationships between these data.

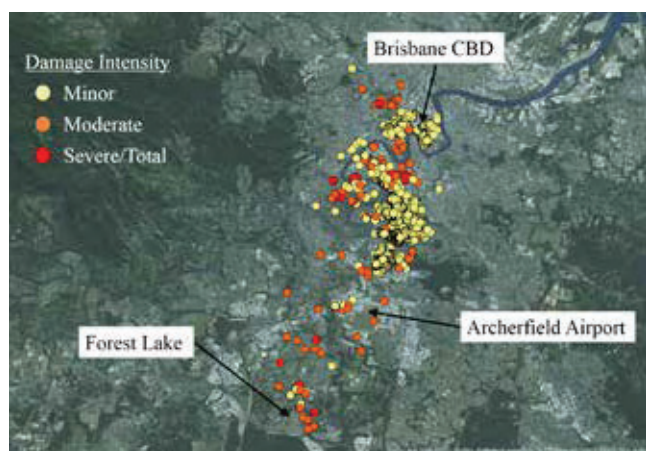
Figure 3: QFES RDA data for the November 2014 Brisbane severe thunderstorm event.

A total of 3,343 RDA data points were collected and analysed (Figure 3). To enable damage comparisons with swaths of Doppler-derived wind speeds (at 200 metre height) and radar reflectivity, RDA points were assigned hail and wind damage modes. The assignments were applied based on term searches within the damage description for each point (e.g. search for the word 'hail') and engineering judgement based on the presence of tree damage or debris (i.e. both would result in an assignment of wind damage). In selected areas, the damage assignments were validated by inspecting the photographs. Summary statistics for the hail and wind damage are shown in Figure 4. Of the 3,343 RDA points, 2,720 were assigned hail (2,425 points) or wind (295 points) damage modes. The most frequent observation was minor damage as a result of hail. Wind damage was far less frequent, but often moderate (e.g. failure of fascia, awnings and smaller sections of roofing) to severe in intensity (e.g. complete roof loss).

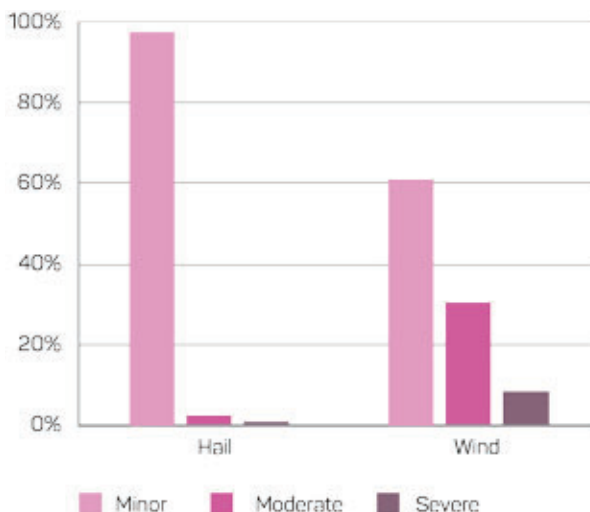
Figure 4: Summary of hail and wind damage modes observed within the QFES RDA dataset after the supercell thunderstorm passed over Brisbane.

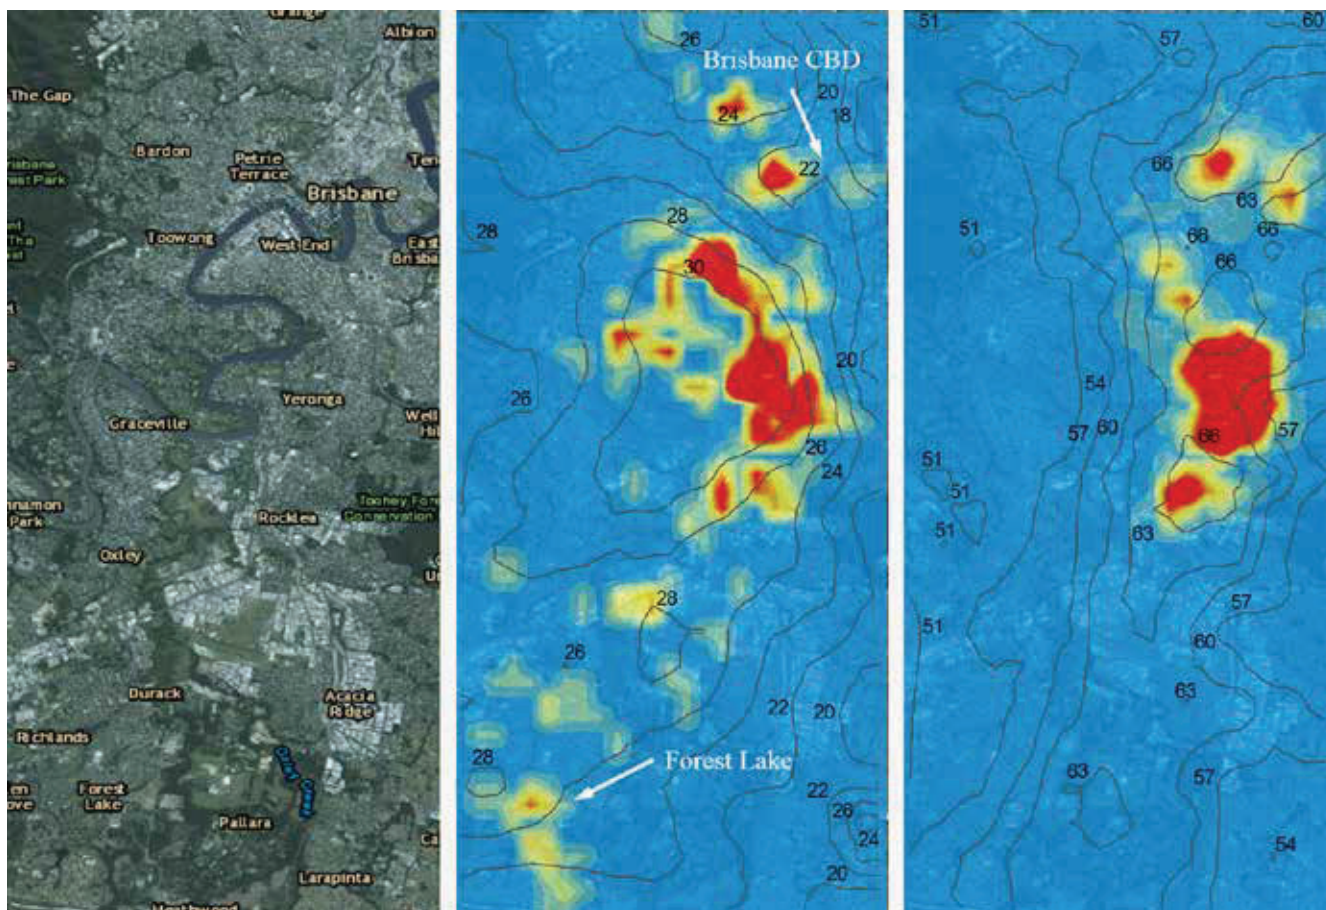
Figure 5: Region of RDA analysis (left), wind damage point density (centre) and hail damage point density (right) based on RDA analysis region. Wind speed (m/s) contours (centre) and reflectivity (dBZ) contours (right) based on radar data analysis.

Hail and wind damage modes were compared with maximum 200-metre maximum dual-Doppler radar velocity and radar reflectivity data in Figure 5. Wind damage was observed from Forest Lake (southeast of Brisbane) through to the Brisbane central business district (CBD). Hail damage was predominantly confined to the region just south of the Brisbane CBD. As the storm propagated to the north-northeast the suburbs of Archerfield, Moorooka, Annerley, West End, Brisbane CBD, Spring Hill and Herston were worst affected. Areas of highest reported wind damage were located along the east and northeast leading edge of the

thunderstorm gust front (i.e. north of Archerfield Airport) with some isolated pockets north of the observed gust front (Figure 5 centre). Over Brisbane, the density of wind damage significantly decreased as the gust front weakened. Most hail damage was collocated with, or a short distance west of, the 200-metre 63 dBZ radar reflectivity contour (Figure 5 right). Considering the horizontal scales of radar data used in this study, the maximum dual-Doppler radar horizontal velocity and radar reflectivity contours show good agreement with the location of peak RDA data point density plots. These observations provide important insight into potential uses for RDA data and how radar information may be processed to help predict the extent of damage for localised wind events.

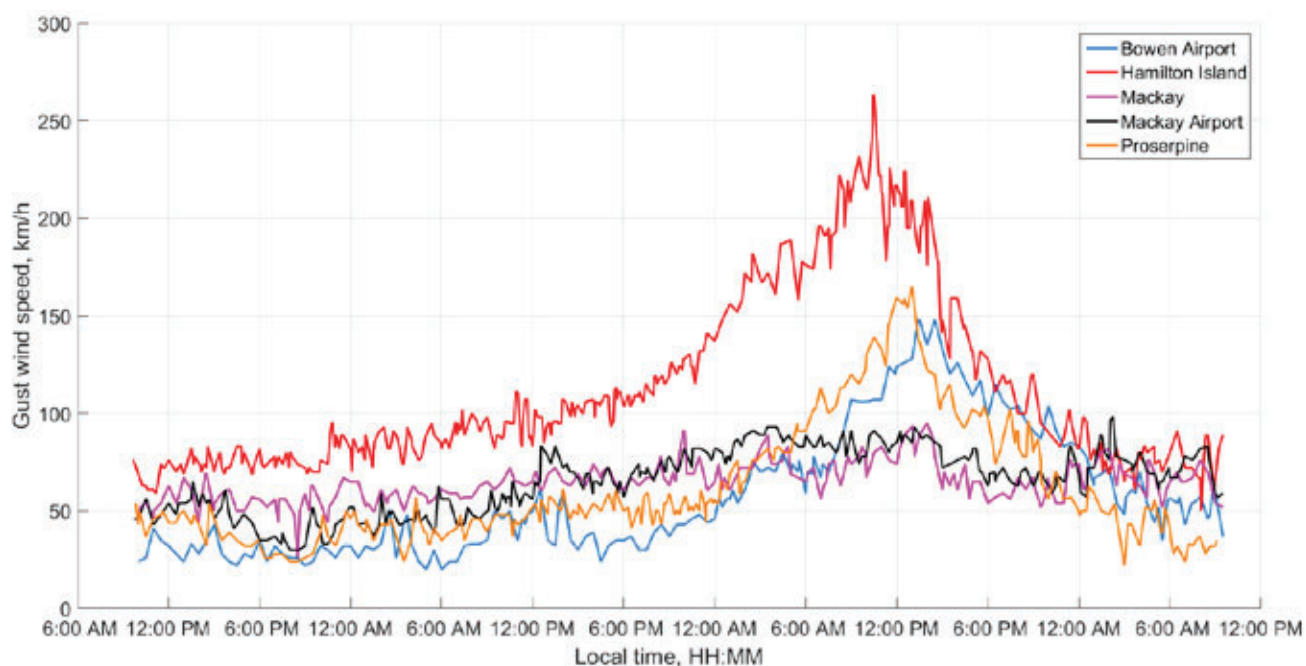
Figure 6: BoM Automatic Weather Station 3-second gust wind speed time histories 26/03/2017-29/03/2017.

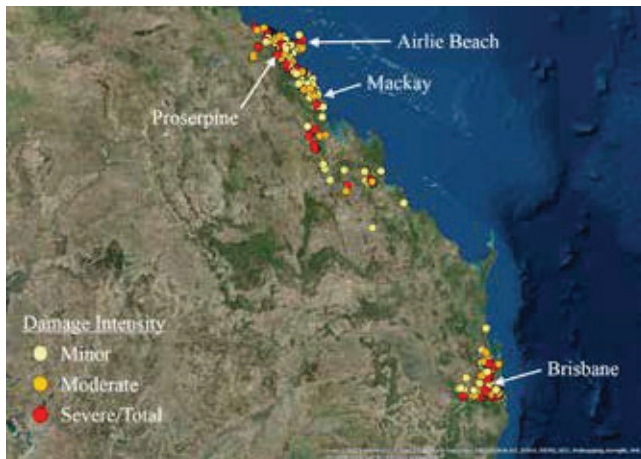
Figure 7: QFES RDA data for Tropical Cyclone Debbie in March 2017.

Tropical Cyclone Debbie was a severe, slow moving storm with a relatively large wind field that crossed the Queensland coast south of Bowen around midday on 28 March 2017. The cyclone caused wind and water damage to buildings in the area between Bowen and Mackay, with the most severe damage in and around the communities of Bowen, Proserpine, Airlie Beach and Hamilton Island. AWSs at Bowen Airport and Proserpine recorded maximum three-second gust wind speeds of 148 km/h and 165 km/h, respectively (Figure 6). Extensive damage was also observed in SE Qld and NE NSW due to flooding several days after landfall. Approximately 11,200 RDA surveys (Figure 7) were conducted from north of Airlie Beach to Brisbane.

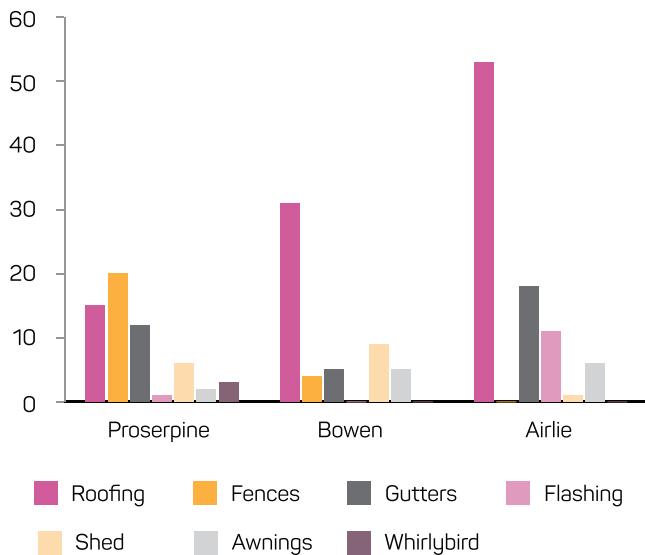
Figure 8: Summary of damages to various components for all building types (e.g. house, unit, commercial) based on analysis of RDA data in Proserpine, Bowen and Airlie Beach.

RDA data were also used to investigate relative damage proportions to building components. Figure 8 shows the distribution based on results of term searches within the damage descriptions. A high frequency of issues related to ancillary items like gutters, fences and sheds. However, of the 2,738 points that recorded damage, 799 (29 per cent) did not include any descriptive comments about the type of damage observed. Furthermore, assessments that did include comments were not always complete (may have mentioned loss of roofing but no mention of fences since roof damage was more important for that building) so the proportions presented should be considered as lower bounds. Complicating things further, all building types were included in the analysis (e.g. houses, commercial, strata) since building type was listed as 'unknown' in most cases. This affected the statistics for damage to components in each of the three regions (e.g. strata properties with flashing are more prevalent in Airlie Beach than in Proserpine).

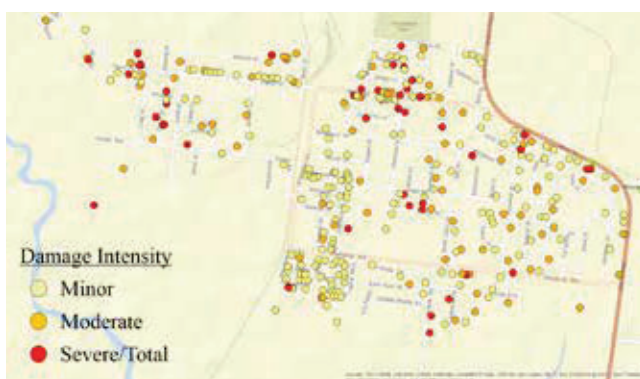
Figure 9: RDA damage points in Proserpine from Tropical Cyclone Debbie (undamaged buildings not shown).

The RDA survey in Proserpine was more comprehensive and enabled detailed analysis. Over 90 per cent of buildings were investigated, including damaged and undamaged properties (Figure 9). In many cases, RDA teams (Fire and Rescue NSW and QFES) knocked on doors and discussed damages with property owners. The majority of buildings were single-family homes (81 per cent), commercial (10 per cent) or unit/townhouse (six per cent). Of the 1,283 houses surveyed in Proserpine, 466 (36 per cent) were recorded as having some form of damage.
