Role of building codes and construction standards in windstorm disaster mitigation

David Henderson and John Ginger from James Cook University, examine the role of Australia's building code and construction standards in a number of windstorm disaster mitigation situations.

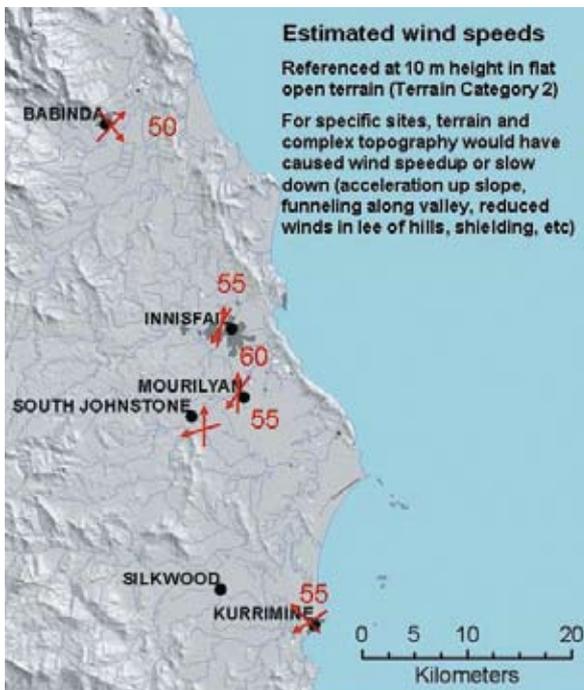
Figure 4: Estimates of wind speed in flat open terrain (Henderson et al., 2006)

The CTS conducted a detailed study of the performance of buildings in the Innisfail region and relevant codes and standards following the category 4 Tropical Cyclone Larry (Henderson et al., 2006). The study estimated that peak gust wind speeds that impacted on the region were in the order of 50 to 60 m/s (referenced to 10 m height in open terrain), as shown in Figure 4, which is less than the region's ultimate limit state design wind speed of 69 m/s.
